Date: November 21, 2010  
To: Water Solutions Engineering Customer  
Subject: Boiler Inspection on November 17, 2010

## **Background**

Two (2) gas fired boilers are used to produce steam. The older boiler is a water tube type capable of producing approximately 35,000 lbs. of steam per hour and is typically only used for back up situations. The new boiler which was installed in 2008 is a fire tube capable of producing 23,500 lbs. of steam per hour and is the primary boiler for the plant. Until August 2010, the boiler chemicals used to treat this boiler was EDTA, Sulfite, and Amine. During the July 2010 boiler inspection of the new boiler, large amounts of iron scale were discovered inside the bottom of this boiler which was of great concern. In August of 2010, the treatment program was changed to a polymer/phosphate blend, liquid sulfite, and amine. The previous EDTA treatment program was premixed with softened water and fed to the feed tank; however, the new chemical program was recently changed to direct feed of the three chemicals using independent chemical pumps. A boiler blowdown controller has also been installed but is not operational at this time. Two very critical items s

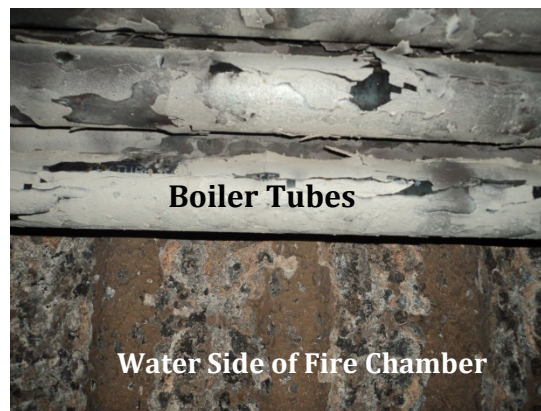
### **Front Left Port—Boiler Tubes and Water Side of Fire Chamber**

Pictures were taken through the left front port (see below). As you can see, the tubes have a very thin and flaky scale covering approximately 75% of the water side. Since we do not have pictures from the July 2010 inspection for comparison, we are assuming this is the result of the entire chemical treatment drum (polymer/phosphate) being fed just a week prior to this inspection. If that is the case, this scale will be primarily phosphate scale. However, if the tubes showed significant scale buildup in the July 2010, this could be the result of the softening and removing the previously deposited scale. Lab results from the scale analysis should provide some clarification. The water side of the fire chamber shows evidence of pitting most likely caused by the EDTA treatment program.

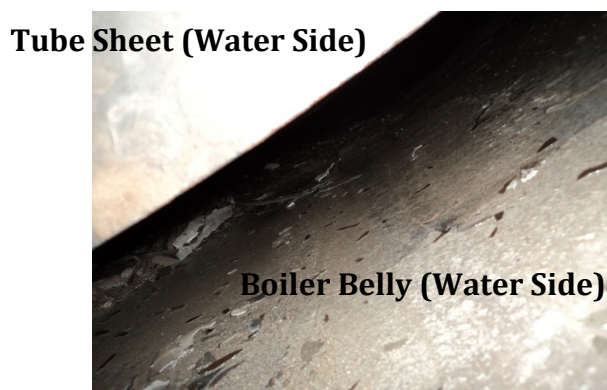
### **Rear Port—Bottom Section of Tube Sheet (Water Side) and Belly**

Pictures were taken through the rear port (see below) and, as you can see, the flakes which can be seen on the tubes are also present on the belly of the boiler. It is recommended but not necessary that these flakes be removed from the boiler before start-up. Again, scale analysis will provide more answers to the origin of this scale. However, it is not iron scale which was present during the July 2010 inspection.

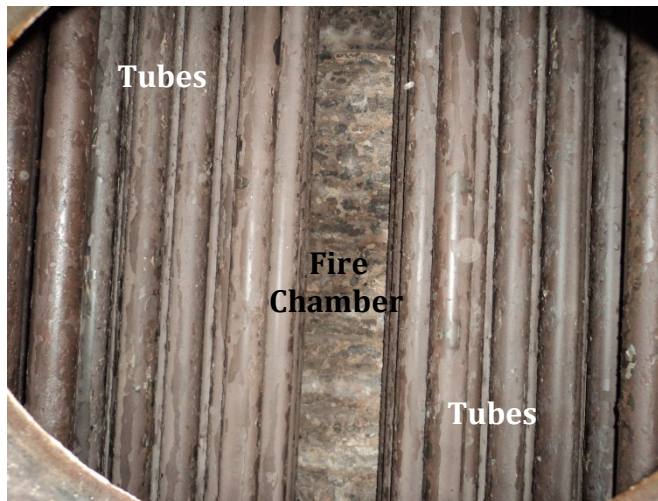
**Top Port---Top Section of Tubes**

Pictures were taken through the top port (water side) and you can see the same thin, soft and flaky scale on this section of tubes as well. It is a little more difficult to see as the section was still wet as the port was opened just prior to taking these pictures and moisture was present. We do try to achieve a very thin and non flaky coating on the water side of the tubes to prevent corrosion; however, the coating present during this inspection was too thick and too flaky. Again, the lab analysis of the scale will provide more insight.

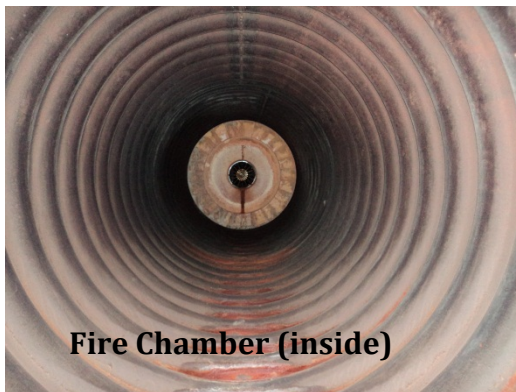
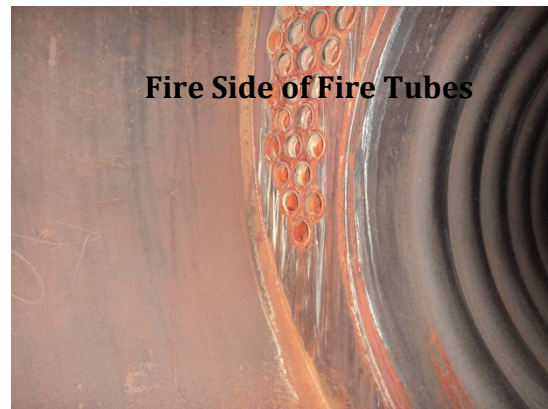
**Fire Side of the Fire Tubes and the Open End of the Fire Section**

The fire section of the boiler was inspected and there were not any evidence of fire side or fuel deposits.
