Date: July 15, 2009
To: Water Solutions Engineering Customer
Subject: Fulton Boilers Inspections on July 14, 2009

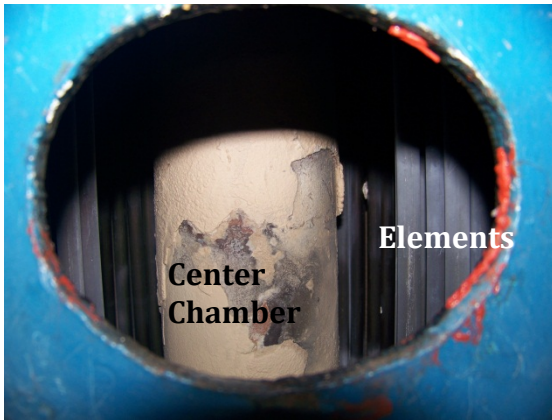
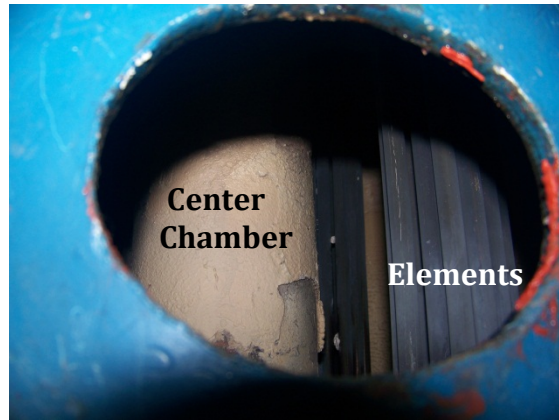
Boiler #1: Top Handhole

This boiler contained the greater amounts of scale which appeared to be calcium carbonate. The bottom of this boiler contained scale in excess of ½” in thickness around the shell and center chamber. The surfaces of the electric heating elements showed little to no scale buildup on the top and bottom portions. The pictures below are from the Boiler #1 inspection.

3. Install Stenner Pump Control Module (PCM) to interface between water meter and Stenner pump for precise chemical injection----**Complete**
4. Physically remove as much scale as possible from each boiler prior to putting back in service.

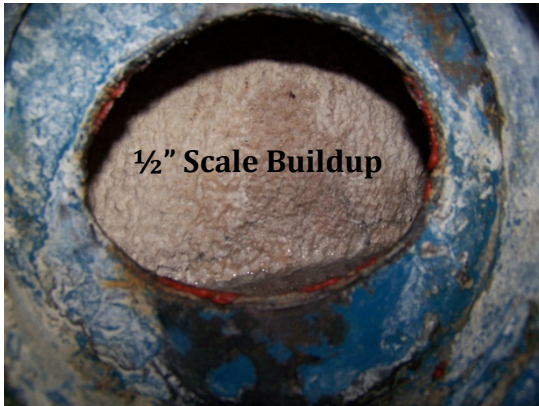
**Boiler #1: Bottom Hand Hole
before Scale Removal**

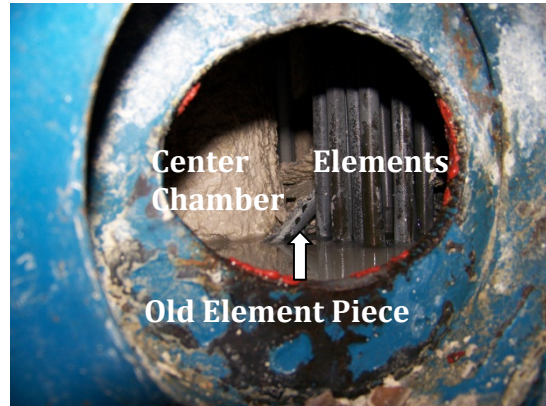
**Boiler #1: Bottom Hand Hole
after Scale Removal**

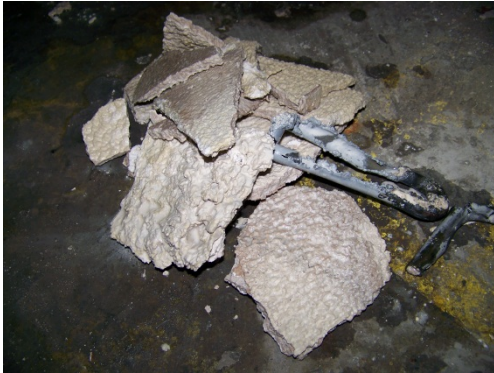
Boiler #1: Scale from Bottom Hand Hole

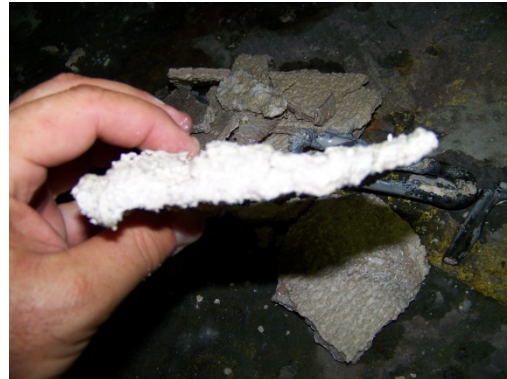
Boiler #1: 1/2" Thick Scale from Bottom Hand Hole

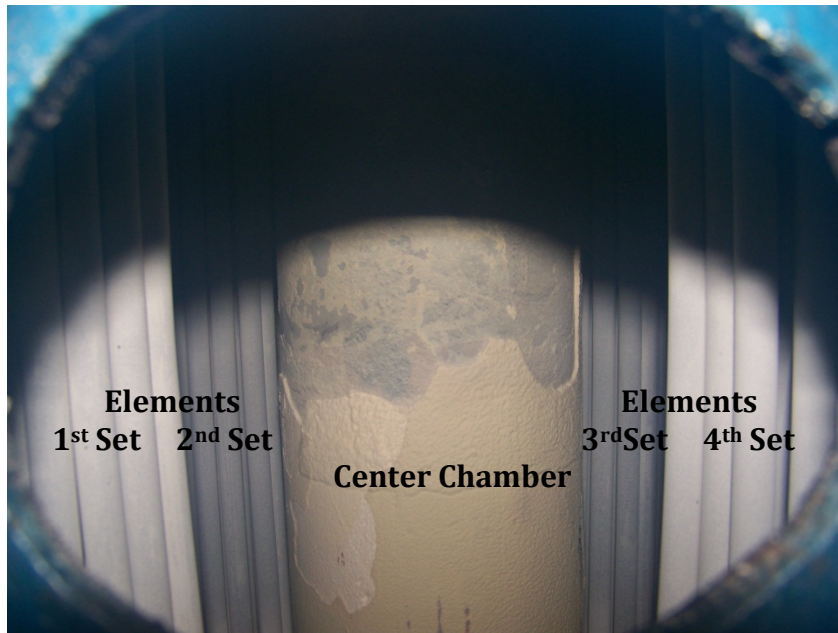
Boiler #2: Top Hand Hole

Scale layer can be seen on the center chamber and the four (4) elements are shown with the white scale layer more noticeable on the forward most sets (1st and 4th).

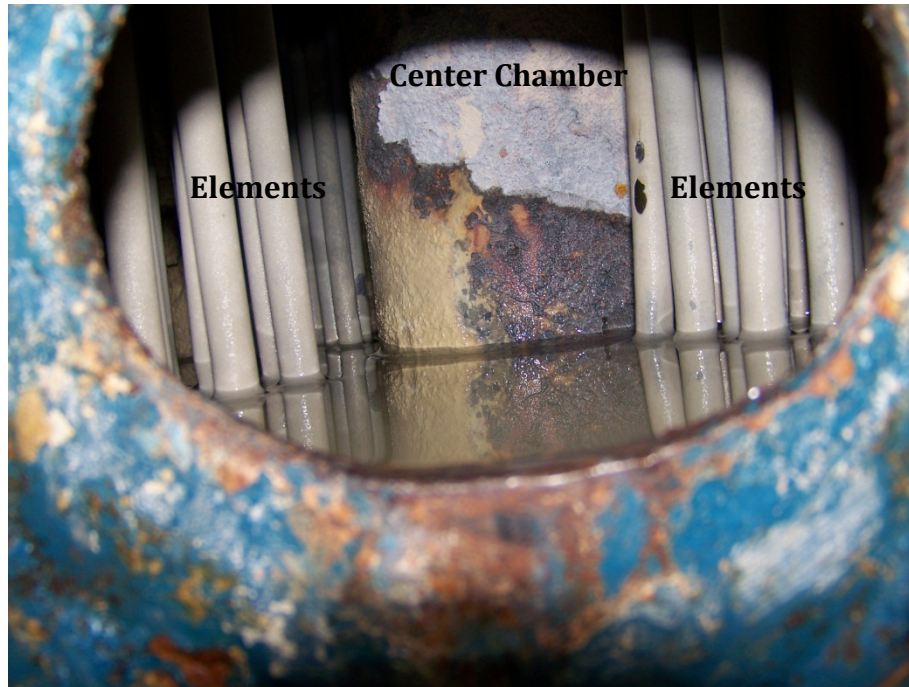
Boiler #2: Bottom Hand Hole

From the picture above, increase scale buildup can be seen on the elements in the bottom section of Boiler #2. Also, scale and corrosion is noticeable on the center chamber.
