Subject: Boiler Inspection on April 29, 2010

## **Background**

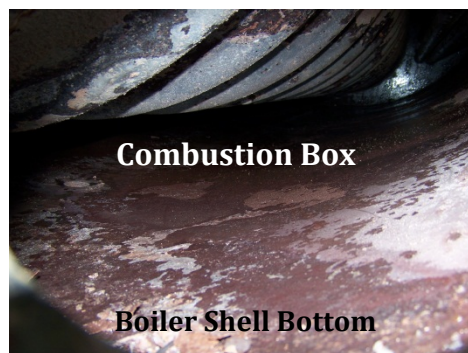
### **Front Port—Boiler Shell Bottom**

Pictures were taken through the front port (see below) and, as you can see, the boiler has some scale but very minimal.

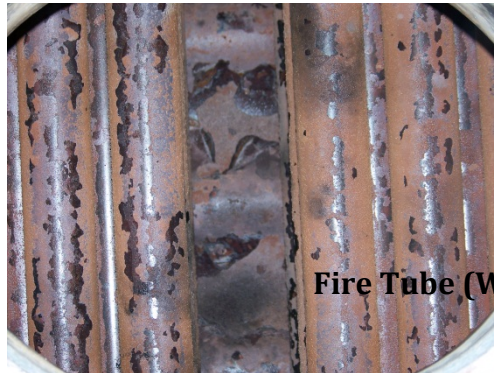
**Fire Tube (Water Side)**

Pictures were taken through the top port (see below) and, as you can see, the fire tubes have some scale on the water side but minimal amounts. Some iron flaking of the pipes is evident but nothing to be concerned about at this time.

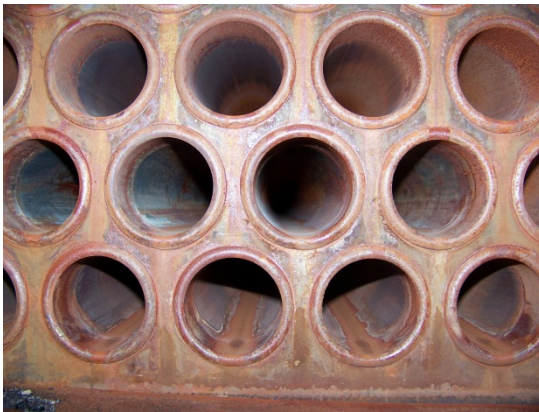
**Fire Side of Fire Tubes**

The fire section of the boiler was inspected and there were not any evidence of fire side or fuel deposits. JCI was working to repair the insulation and insulation sheft that was damaged. Pictures are below.
